# CASE STUDY

## Oil Industry: Lapping Compound Removal

**Product:** Valves for underwater Drilling Operations

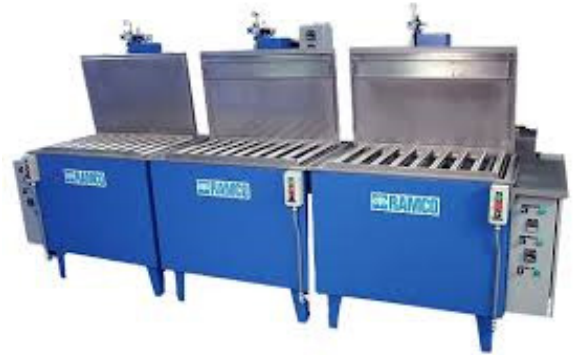
**Customer Improvement Requested:** Lapping compound was not being removed

**Results:** AquaVantage® 815 QR-NF removed all lapping compound
