# World Class Cleaning Solutions

## Case Study

### Auto Intake Manifold Cleaning

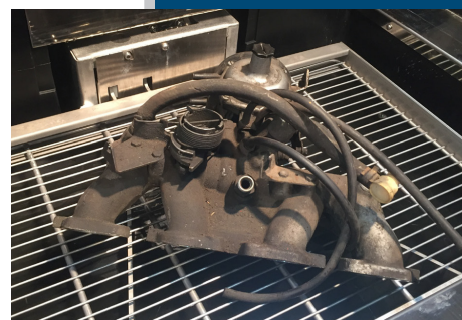
Before

**Parts Cleaned:** Automotive intake manifold. Various models and sizes.

**Removing What Soil:** Oil, particulate, carbon, ambient soils.

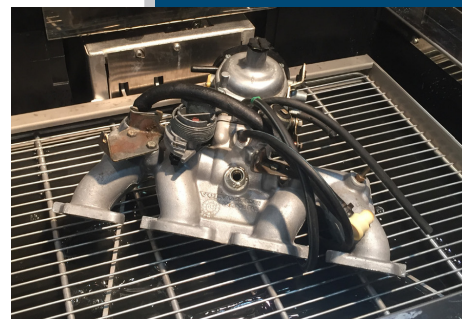
After

Parts are clean, undamaged, restored to original condition.
