# World Class Cleaning Solutions

## Case Study

Manufacturer: Fire Suppression Systems

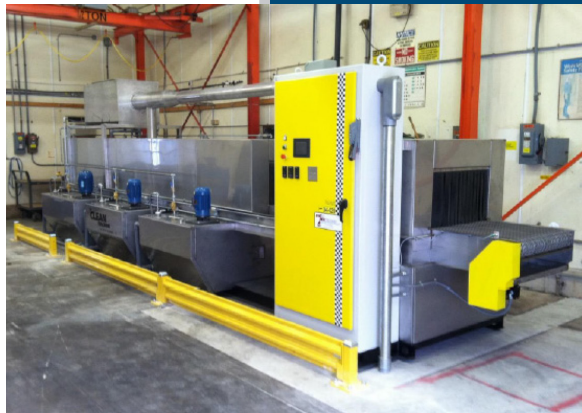
- Product:** AquaVantage® 3800 GD
- Parts Cleaned:** Fire Depression Equipment
- Removing What:** Blazo Cut 935 Coolant
- Scenario:** "In Process" cleaning of parts as they travel through the manufacturing process

Parts are cleaner plus copper & brass elements are no longer tarnished.
